Home Inspection Report For Bob Smith Bolingbrook, IL 60440

Clear Perspective Home Inspection, Inc.

11/9/2005

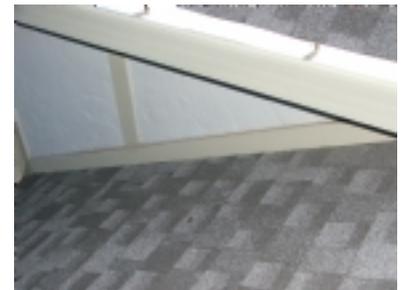
Roof to Wall Flashing:

REPAIR or REPLACE - The siding material is close to the roof. As a rule of thumb, a 1-2 clearance is recommended. In my opinion when the siding material is too close to the roof, this allows for water to wick up into the siding and/or the wall sheathing. Over time this can cause rotting of the various wood sections and can cause water leakage. Water leakage can result in various damage and deterioration to plaster, drywall, structural framing, flooring and other materials. It can also lead to mold problems. Additionally, it cannot be determined if flashing is present. I recommend that you contact a qualified contractor such as a siding installer, carpenter or roofer for appropriate correction action.

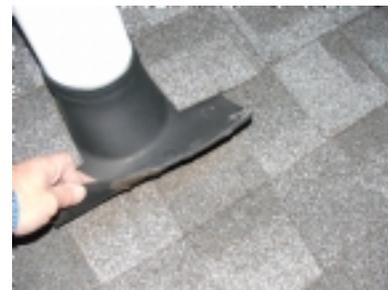
Plumbing Stack Flashing:

REPAIR or REPLACE - Nails are missing. As a rule of thumb, this should be secured. In my opinion this can lead to water leakage and water entry into the building. Water leakage can result in significant damages I recommend you contact a qualified roofing contractor to mitigate the situation.

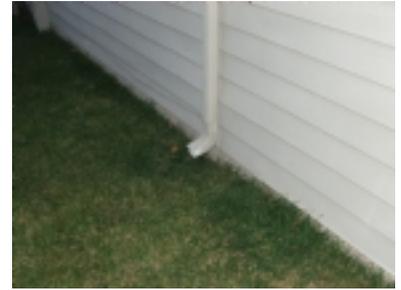
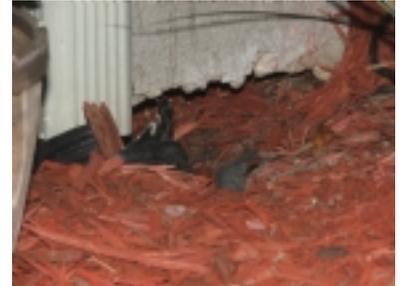
REPAIR or REPLACE - The downspout discharge drains close to the house. As a rule of thumb, a minimum drainage of six feet from the house is recommended. In my opinion when drainage is closer than 6 feet there is an increased potential for water to go back to the foundation and result in water leakage into basements and crawl spaces. Water leakage can cause various problems and damage including damaging drywall, plaster, paneling, flooring and similar. Water leakage can also lead to mold problems. I recommend that you contact a qualified contractor to mitigate the situation if possible.

REPAIR or REPLACE - Mechanical damage is present on the downspouts. In my opinion the downspouts should be repaired to allow water to drain freely. I recommend that you contact a reputable gutter and downspout contractor to mitigate the situation.

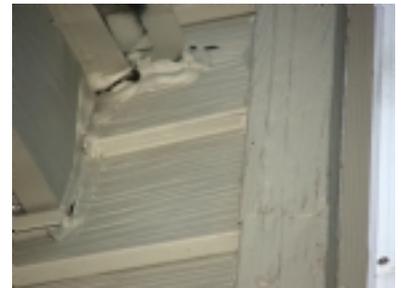
Fascia:

REPAIR or REPLACE - Caulk, sealant and/or flashing detail is deteriorated, damaged or otherwise not effective. In my opinion this can increase the chances for water leakage and other moisture problems. This can lead to various damages such as at the drywall, plaster, flooring, insulation and structural framing. Water leakage and moisture problems can also lead to a mold problem. Appropriate corrective action is recommended by a qualified contractor.

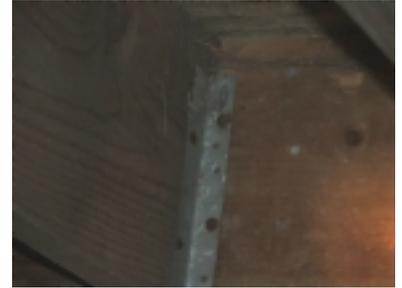
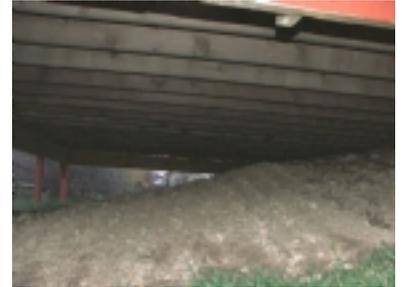
SAFETY - The joist hangers lack nails and/or proper nails. Improper nailing can result in a structural problems and an unsafe condition. Correction by a qualified contractor is recommended.

SAFETY - The distance between ledger board, and the support beam appear to be over spanned. In my opinion, this can result in the floor sagging, or failure and a collapse. A village inspector, or a structural engineer should be called to verify if structure is exceptable.

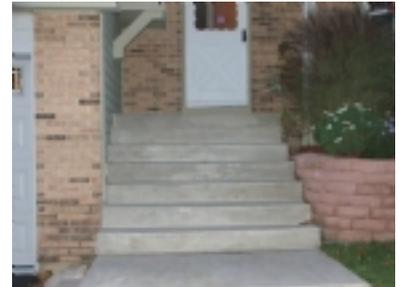
Porches:

SAFETY - There are no guard rails present. This creates an unsafe condition and an increased fall hazard. Corrective action is recommended by qualified contractor.

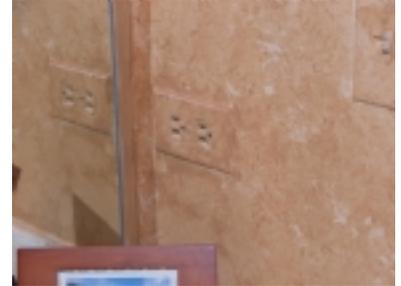
Outlets:

SAFETY / UPGRADE: The bathroom in master bedroom electrical receptacle(s) is not GFCI type. A lack of a GFCI receptacle in this location is considered to be an increase safety risk and an electrical shock / electrocution hazard. Upgrading and installation of GFCI receptacles is recommended.

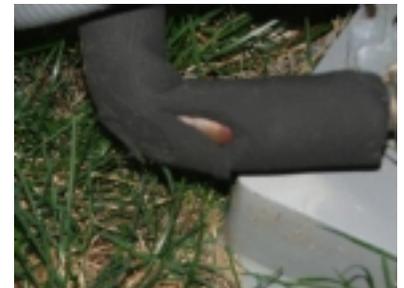
Refrigerant Lines:

MAINTENANCE - The insulation of the a/c refrigerant (suction) line between the outdoor condensing unit and where it enters the house, is damaged or missing. As part of good maintenance, replacement of the insulation is recommended.

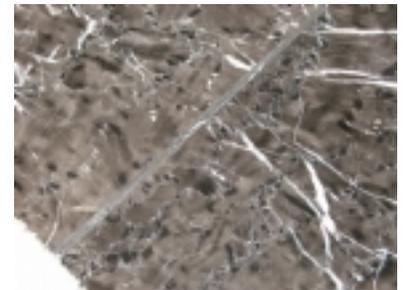
Major Floor Finishes:

REPAIR OR REPLACE - Damaged sections are present. It is my opinion that these should be fixed before someone gets hurt or additional damage is done to the property. I recommend that you contact a reputable handyman to mitigate this issue.

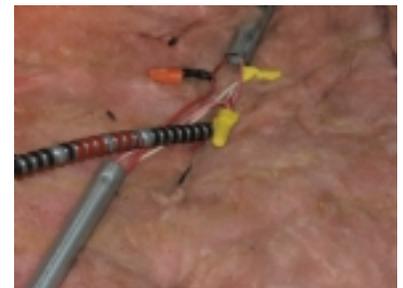
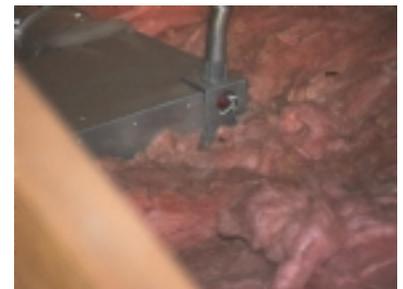
Main Attic:

SAFETY - There are open wiring conductors and splices, improper methods and materials. This is an increased fire / shock hazard and needs to be corrected by a qualified electrician.
